ILLINOIS ENVIRONMENTAL PROTECTION AGENCY

Re: **McHenry Shores Water Company - 111-5020**
May 30, 2000 Inspection Report

An engineering evaluation of the **McHenry Shores Water Company** community water supply has been completed. Field inspection was made on May 30, 2000, by Mr. Chris Johnston and Mr. Manny Abad of this office. Mr. T. P. Mathews, President and Mr. Jeff Claus, Vice President were present during this inspection.

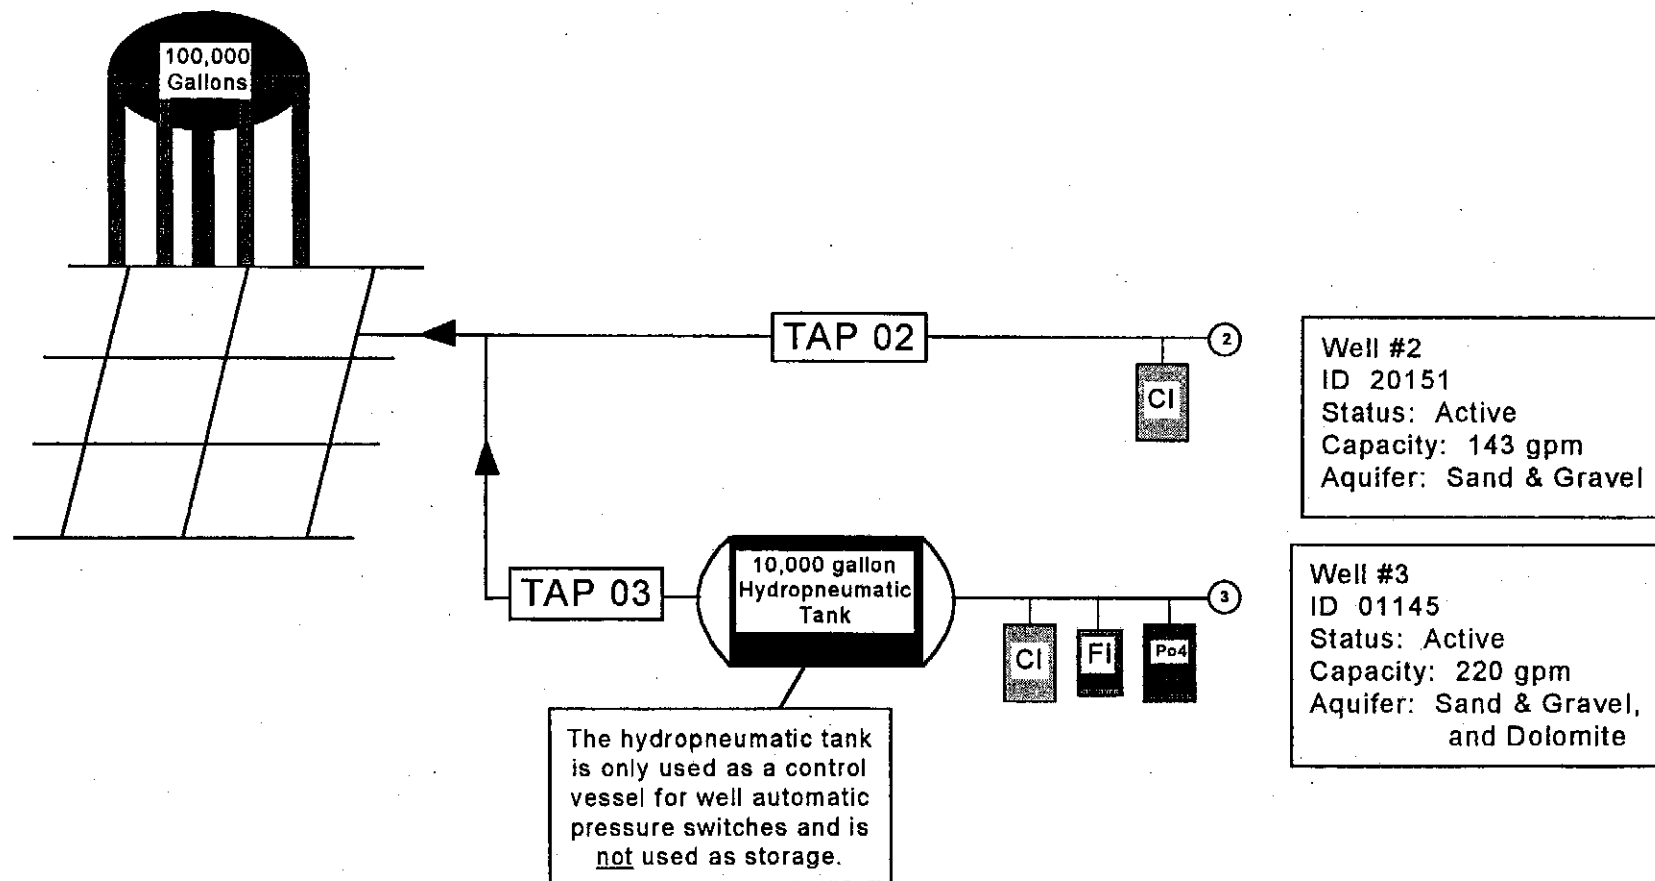
McHenry Shores Water Company
McHenry County - 111-5020

Colors in accordance with *Recommended Standards for Water Works, Section 2.14*
